PRESERVATION ASSESSMENT AND PLAN FOR SPRINGWOOD CEMETERY, CITY OF GREENVILLE, S.C.

Prepared By:
Michael Trinkley, Ph.D.
and
Debi Hacker

CHICORA RESEARCH CONTRIBUTION 440

March 31, 2006

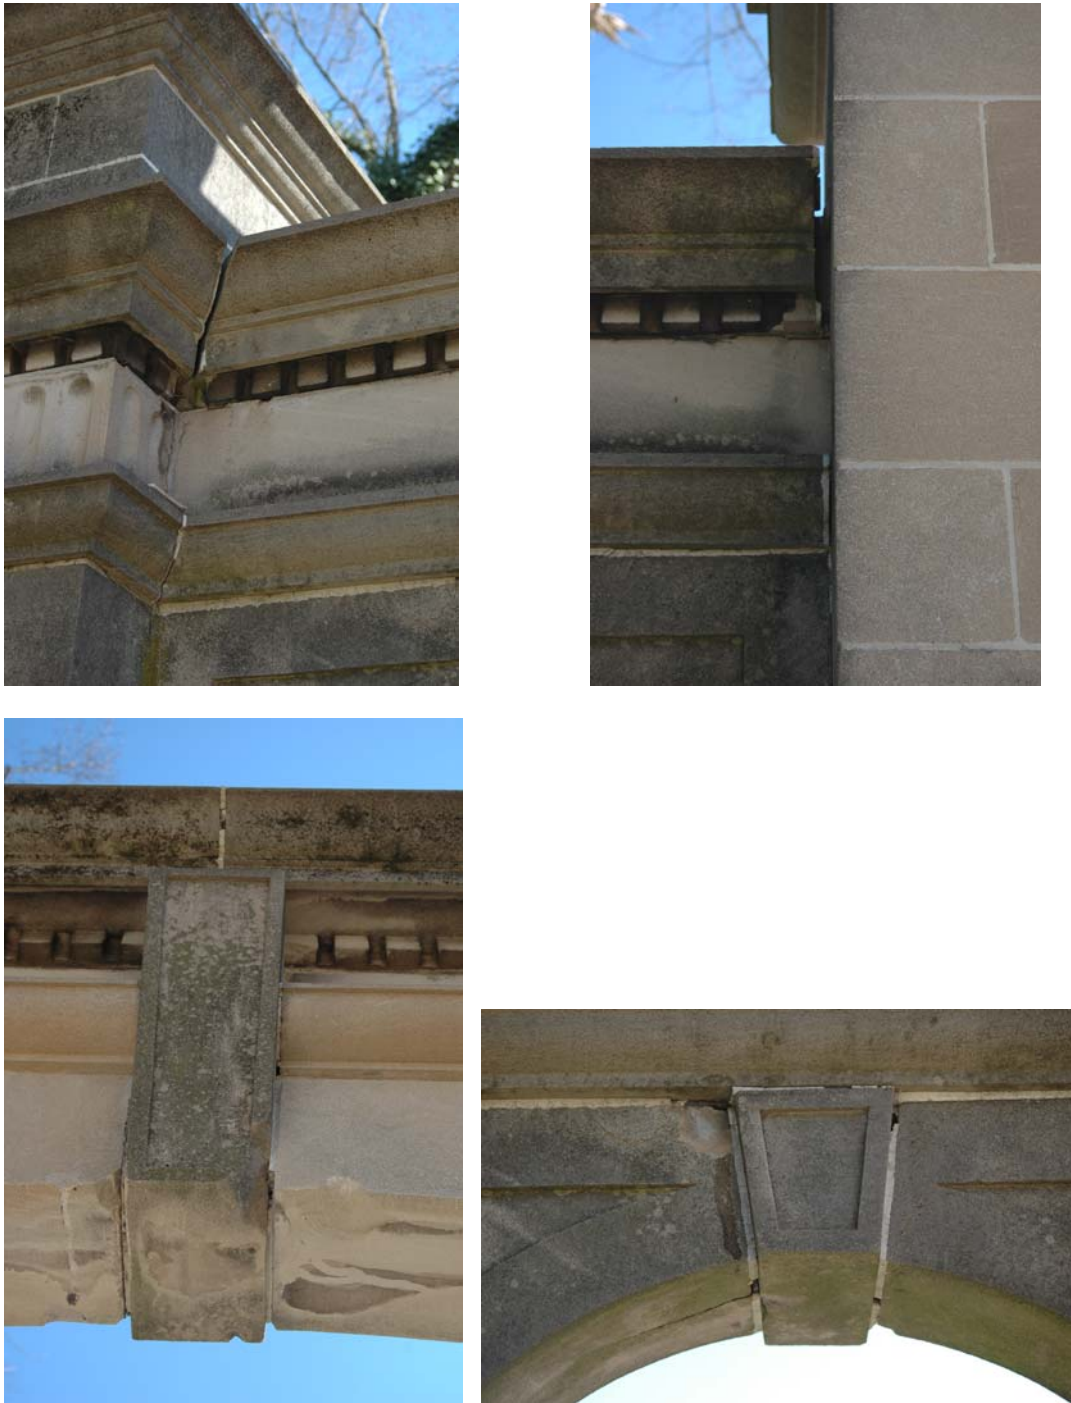
There is evidence of at least some blocks spalling. This is a common problem with

Figure 20. Main gate. Upper left and upper right photos show significant cracks that may reflect movement. Lower left shows damage to arch, probably from vehicles. Lower right shows mortar joints needing repointing and spalling of the sandstone.

There are a variety of mortar joints that are failing. This is a normal process and repointing these joints is an appropriate response. Chicora or another conservation organization should develop specifications for the repointing, to include not only the mortar to be used, but also the appropriate techniques for removing the existing mortar and preparing the joint to receive the new mortar.

Prior to any work on the gate, it should be further evaluated to allow the full extent of problems to be recognized.

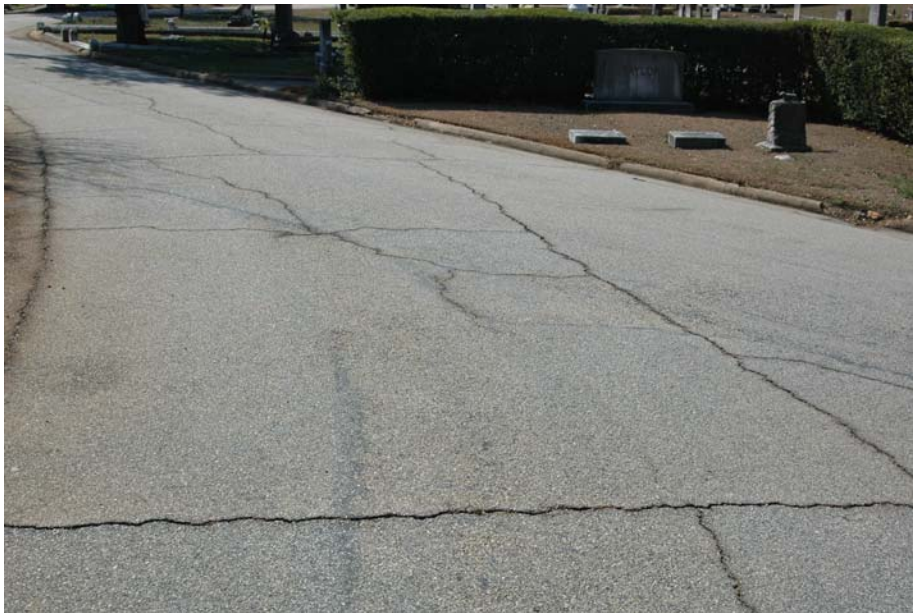
Figure 21. View of a typical road in Springwood showing extensive pavement cracking.

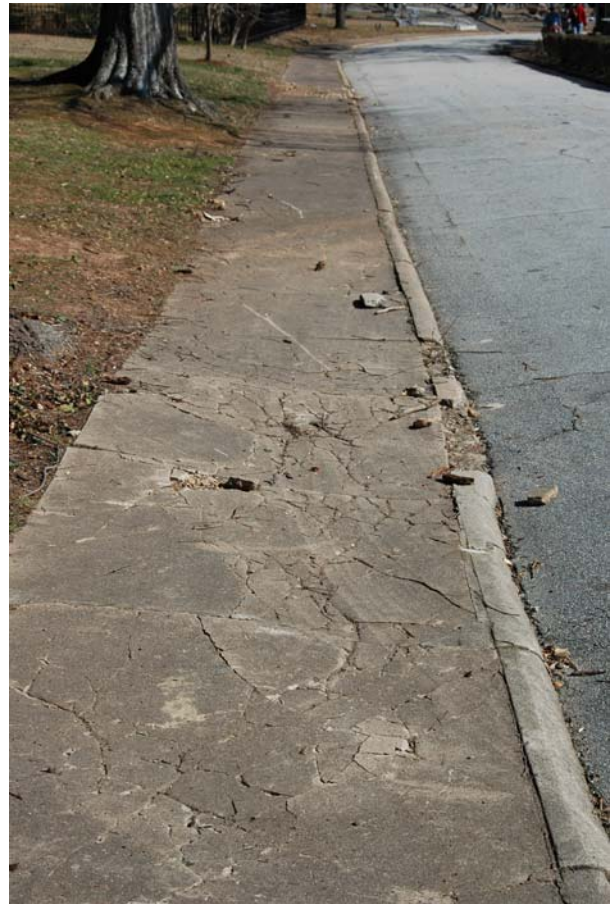
Figure 24. Example of heavily damaged sidewalk that requires replacement for aesthetic and liability reasons.

If contracted out, rather than being done in-house, this sidewalk repair will cost approximately \$7,100.

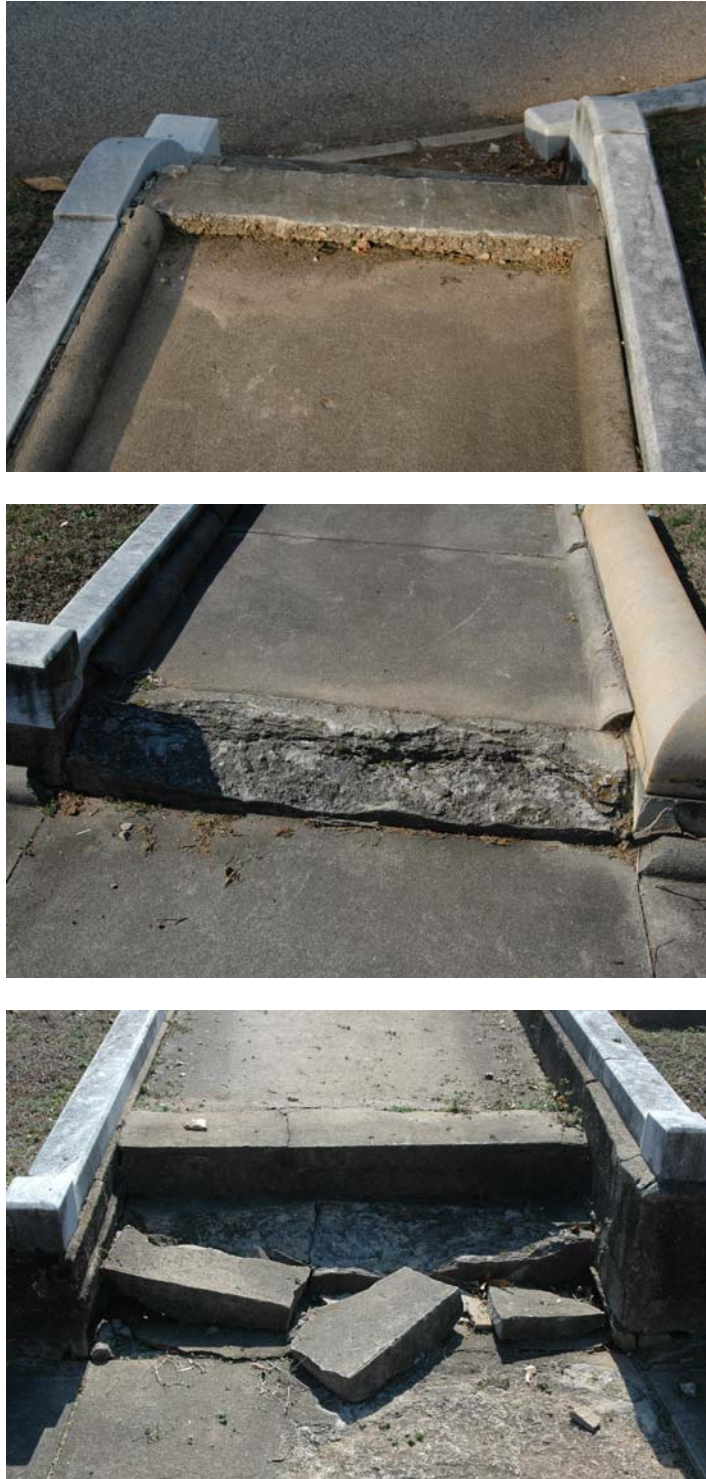
Sidewalk areas within the sections are similarly affected by concrete spalling and deterioration. In several instances sections of concrete have sunk or been displaced, creating a significant trip hazard. Steps in particular have deteriorated to an alarming extent. Throughout the various sections we estimate that there are about 100 linear feet (400 square feet) of sidewalk that requires immediate attention, coupled with at least six sets of stairs that need to be completely removed and relaid (approximately 40 linear feet measured “at nose”).

Figure 25. Plot sidewalk deterioration. Example of sunken sidewalk creating a trip hazard (top) and examples of deteriorated steps. All pose a significant liability to the City (middle and bottom).

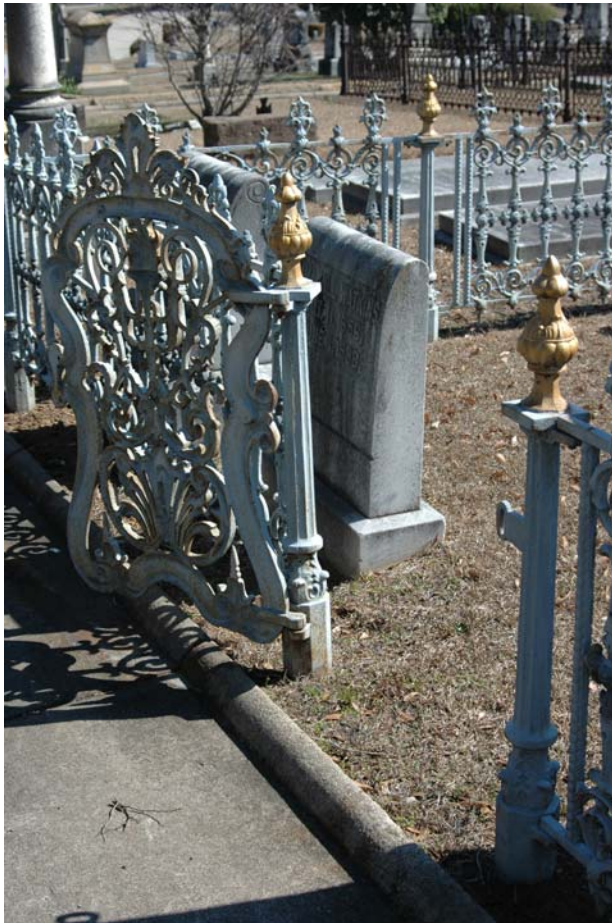
Figure 27. Example of unsecured gate that could be easily stolen. This and other plot gates in the cemetery should be secured using woven stainless steel wire to attach the gate to its hinge post.

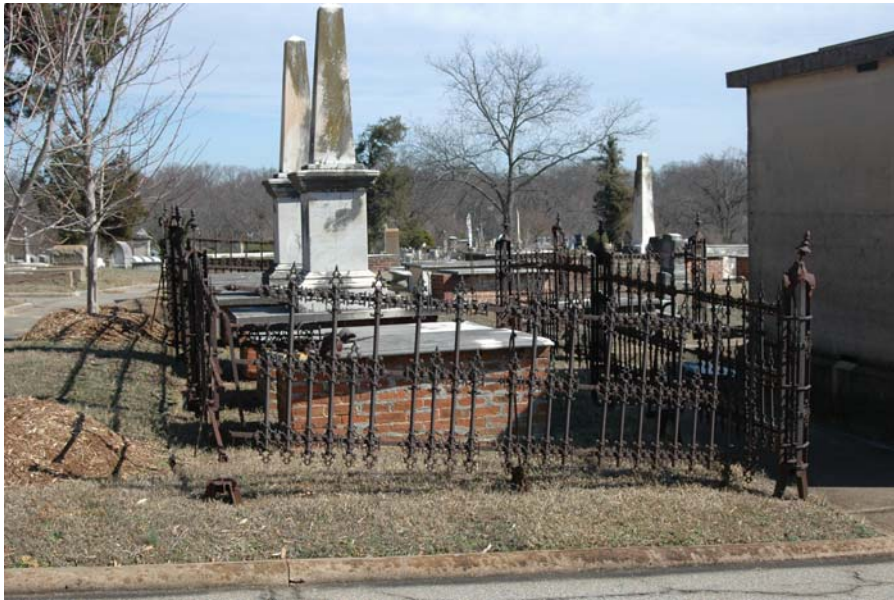
These fences, however, are in various states of deterioration and several require immediate attention. One has been previously illustrated (Figure 27). It is the most elaborate, evidencing remnant gray and gold paint. The paint is in satisfactory condition and, other than securing the gate, this fence requires no immediate attention.

Figure 29. Example of a Springwood fence evidencing multiple, significant problems.

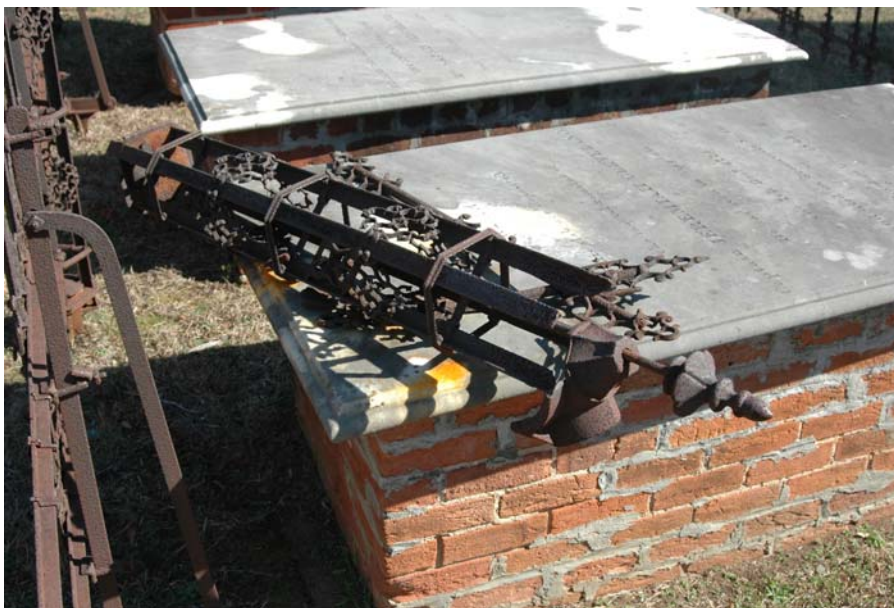
Figure 30. The corner post from the fence shown in Figure 29 has been placed on top of a marble ledger. This not only encourages the theft of the ironwork, but also is resulting in significant iron staining of the marble. Examples of poor maintenance such as this endanger the historic fabric and also increase the cost of future conservation treatments.

The City should collect, label, and store all such

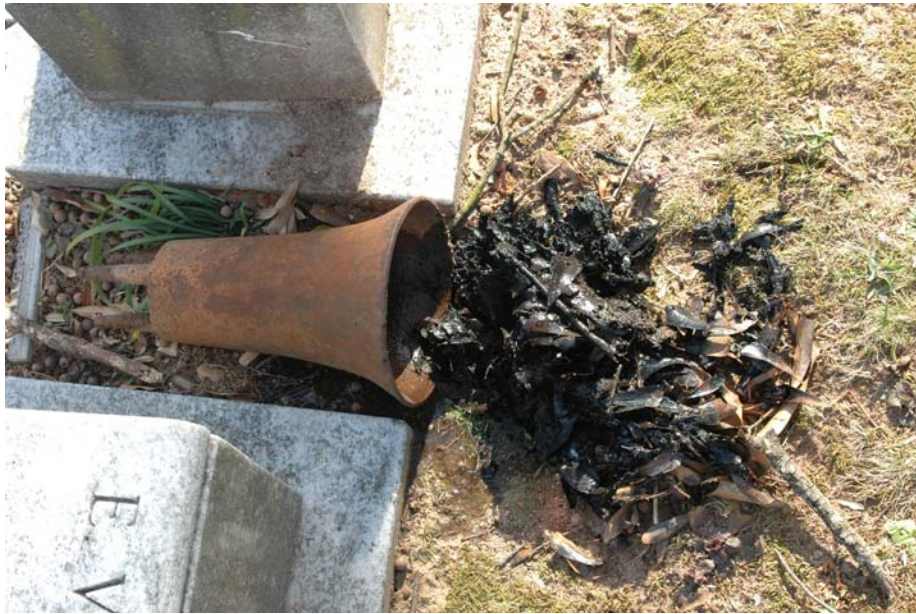
Figure 33. Example of a small cast urn on a plot. It is in need of painting and will require periodic maintenance, primarily draining to remove water and debris. This is an activity that could be scheduled by the Friends of Springwood.

immediate attention. It should be treated like the fences previously discussed, and then replaced in the lot. As part of the ground maintenance it should be periodically drained of debris. This is an activity that could be scheduled by the Friends of Springwood Cemetery.

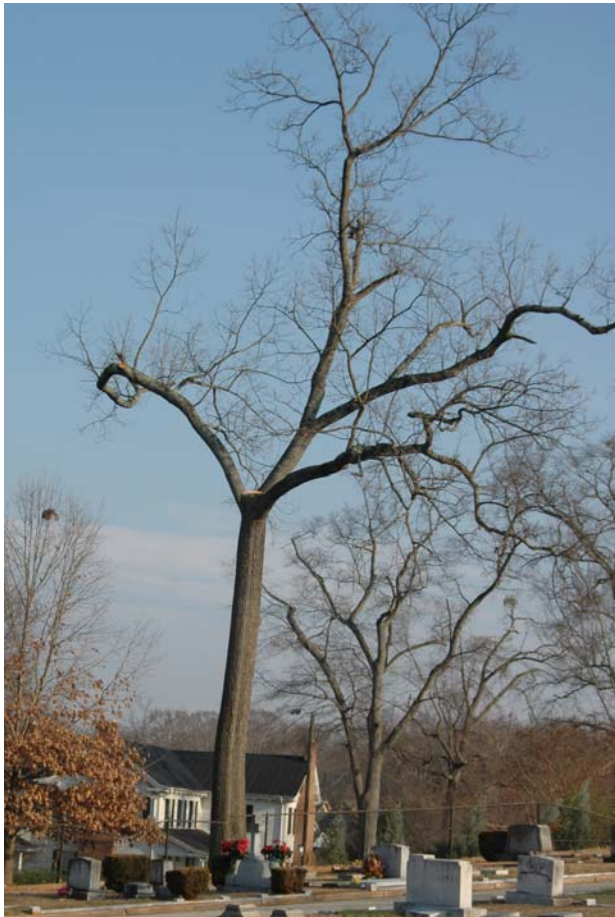
Figure 35. Example of a topped tree. With the main branch removed, the tree is unlikely to thrive. A better approach would be removal and replanting.

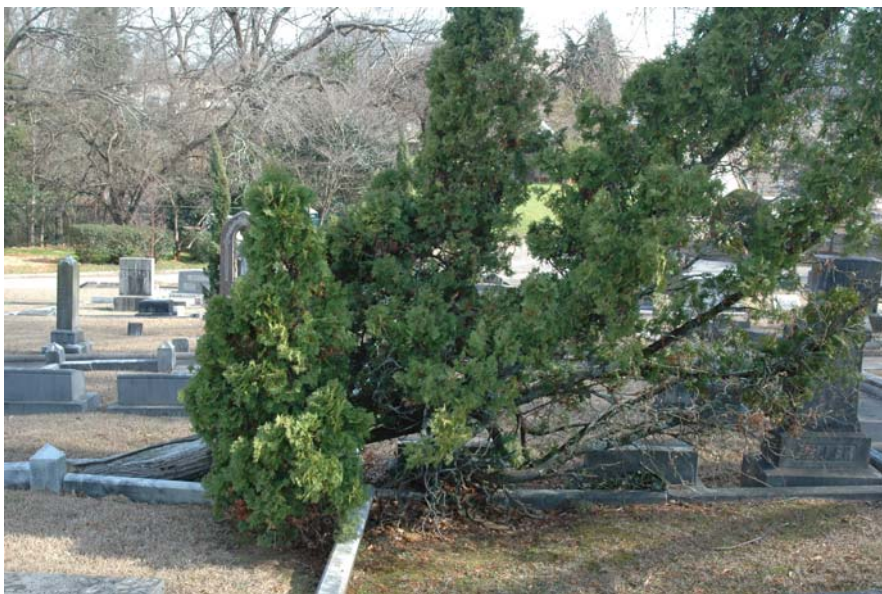
Figure 39. Example of a cedar that has partially collapsed and been allowed to remain in that position.

There are a number of trees which require pruning for either thinning or cleaning.

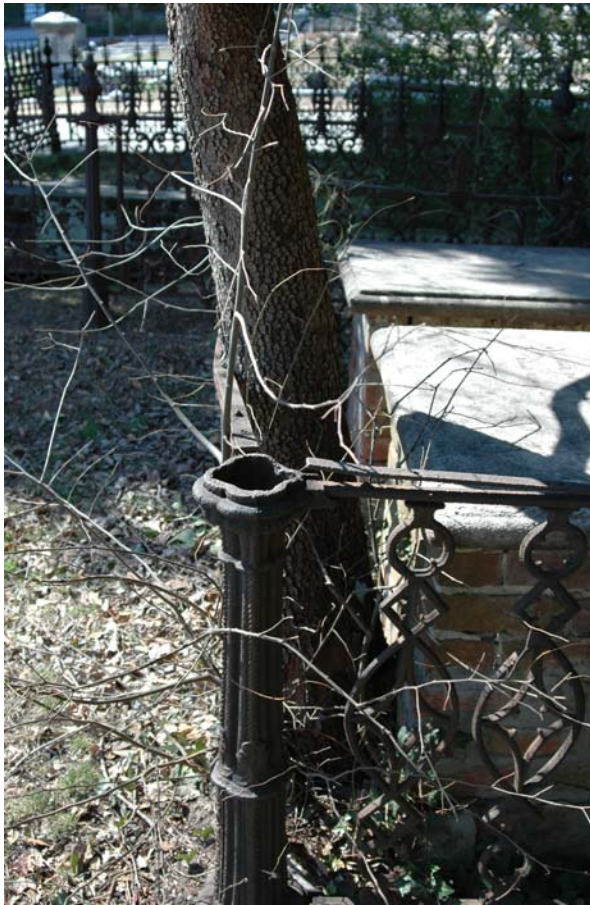
Figure 40. Example of a volunteer tree growing up between an iron fence and brick box tomb. This tree should be removed to prevent additional damage (note the fence is already bent outward).

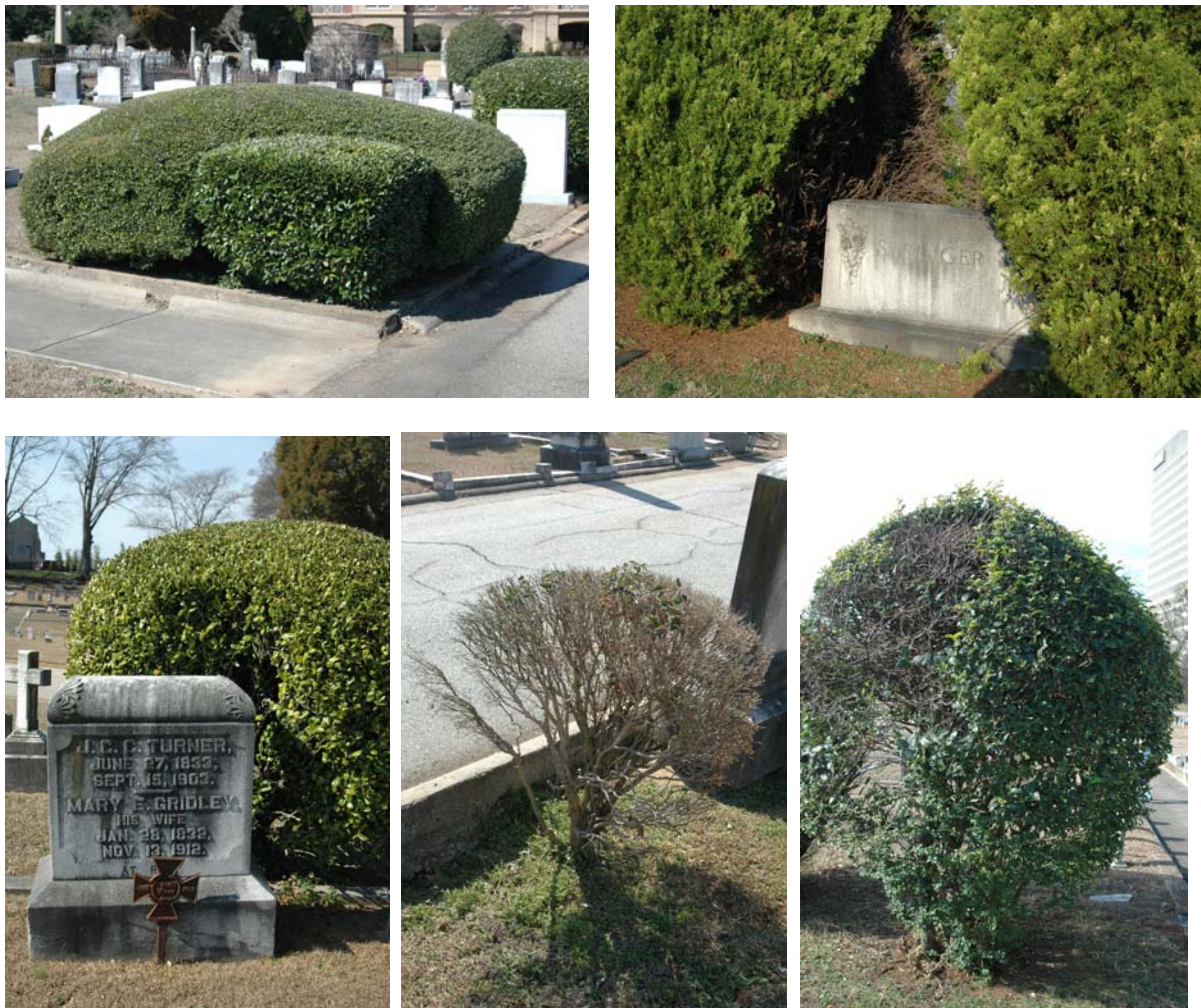
Many of the boxwood at Springwood also exhibit heavy winter damage. In some cases the entire plant has been killed. In other cases only the outer (typically sheared tops) have been damaged. All of this damage should be pruned off in the spring, allowing new growth to replace it. Problems such as this can also be minimized by ensuring adequate late fall

Figure 43. Common shrubbery problems at Springwood Cemetery. Upper left shows unnaturally sheared shrubs. More appropriate is careful pruning to allow the plant's natural shape to appear. Upper right are junipers overtaking a monument that have had portions cut out to artificially and unnaturally expose the stone. Lower left shows another example of a shrub being artificially pruned around a monument. A better approach might be renewal pruning to reduce the overall size or relocation of the shrub. Lower middle shows an entirely dead shrub that needs to be removed and replaced. Lower right is a shrub with multiple problems, including an unnatural, fanciful shape resulting from shearing and deadwood which has not been removed. Careful inspect reveals that this is actually a combination of several different species that have grown together and are being pruned as one.

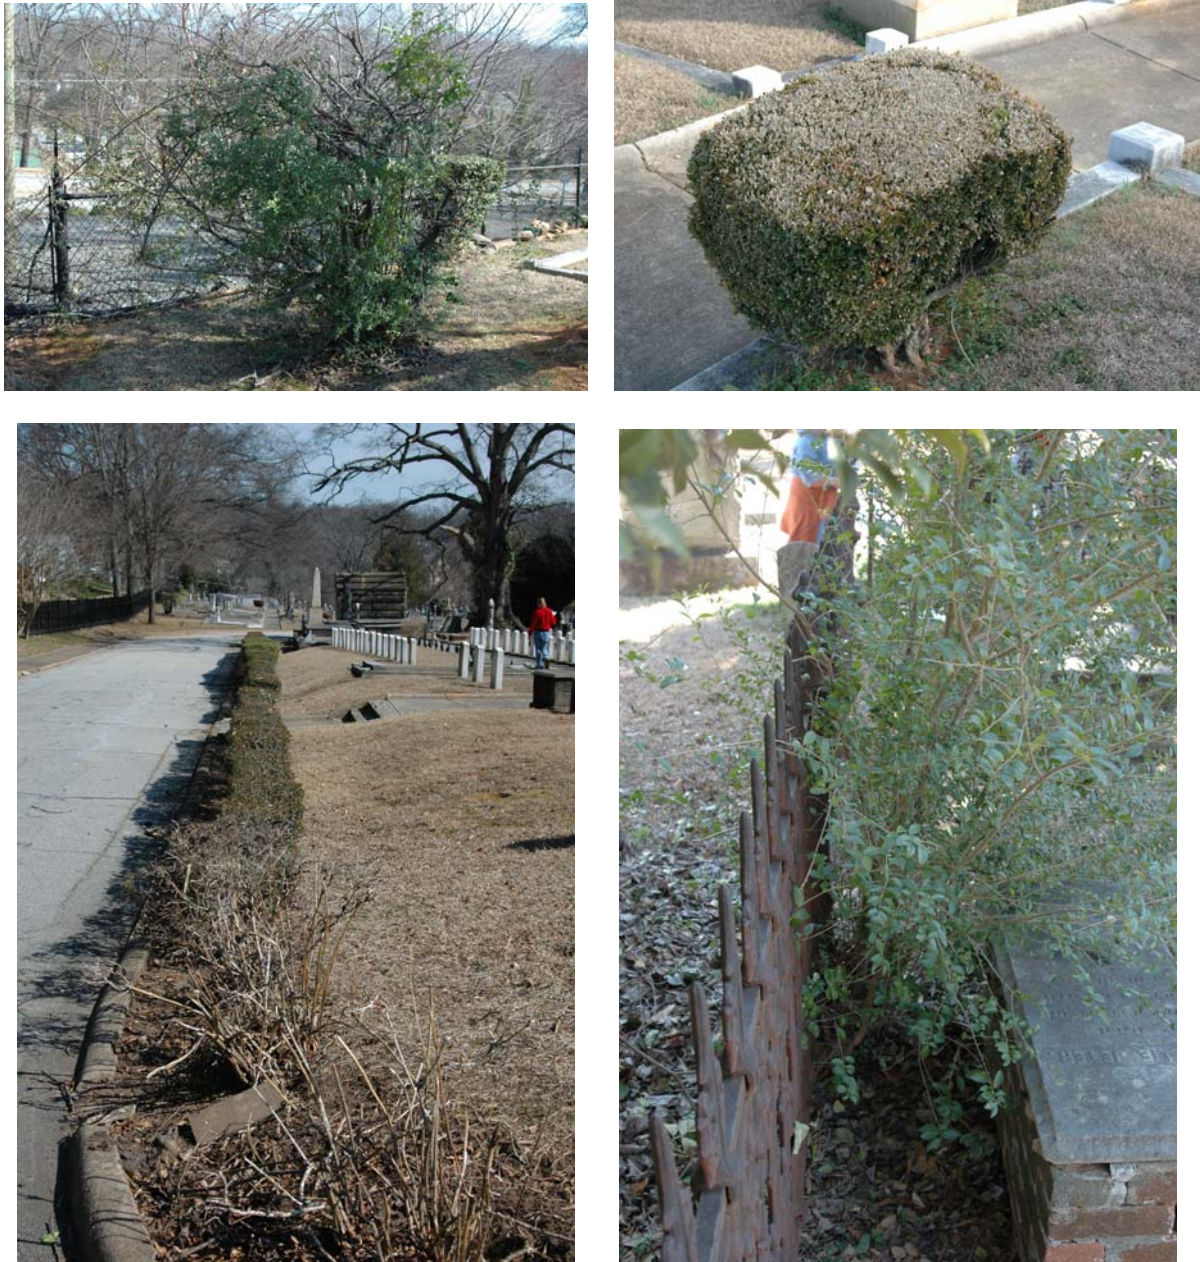
Figure 44. Common shrubbery problems at Springwood Cemetery. In the upper left is a damaged elaeagnus that requires careful pruning to remove broken limbs from a downed tree and dead wood. Upper right is an example of heavily freeze damaged boxwood that requires not only removal of the damaged outer foliage, but also significant pruning to open the interior. The lower left photograph shows a badly damaged boxwood hedge at the entrance to Springwood. This significantly detracts from the aesthetics and historic context of the Cemetery. Simply removing the dead plants will also alter the landscape design and affect the historic integrity of the National Register property. At the lower right is an example of scrub vegetation that should be entirely removed before it causes problems with the fence or box tomb.

condition. Those which can be saved by careful pruning should be. Those which are dead or which cannot be rehabilitated should be removed and similar species replanted.

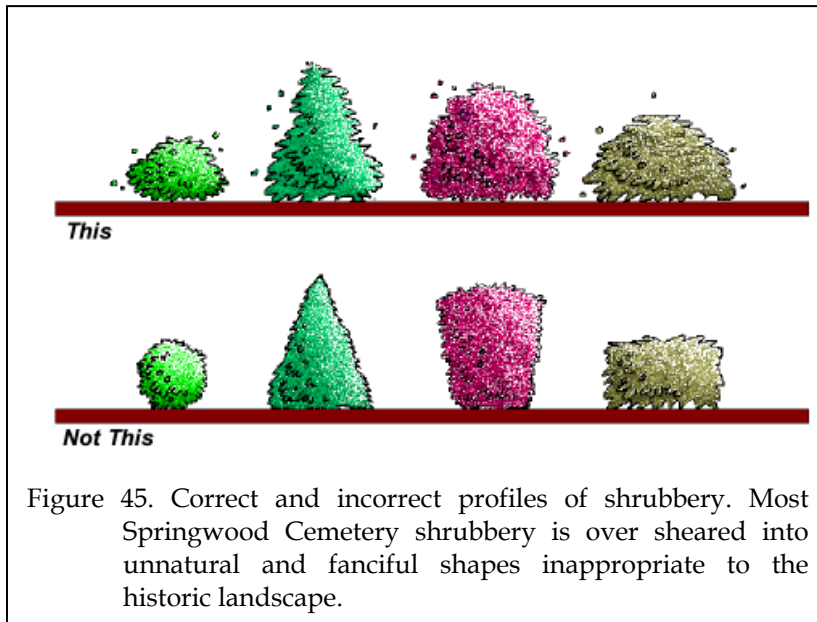
Figure 45. Correct and incorrect profiles of shrubbery. Most Springwood Cemetery shrubbery is over sheared into unnatural and fanciful shapes inappropriate to the historic landscape.

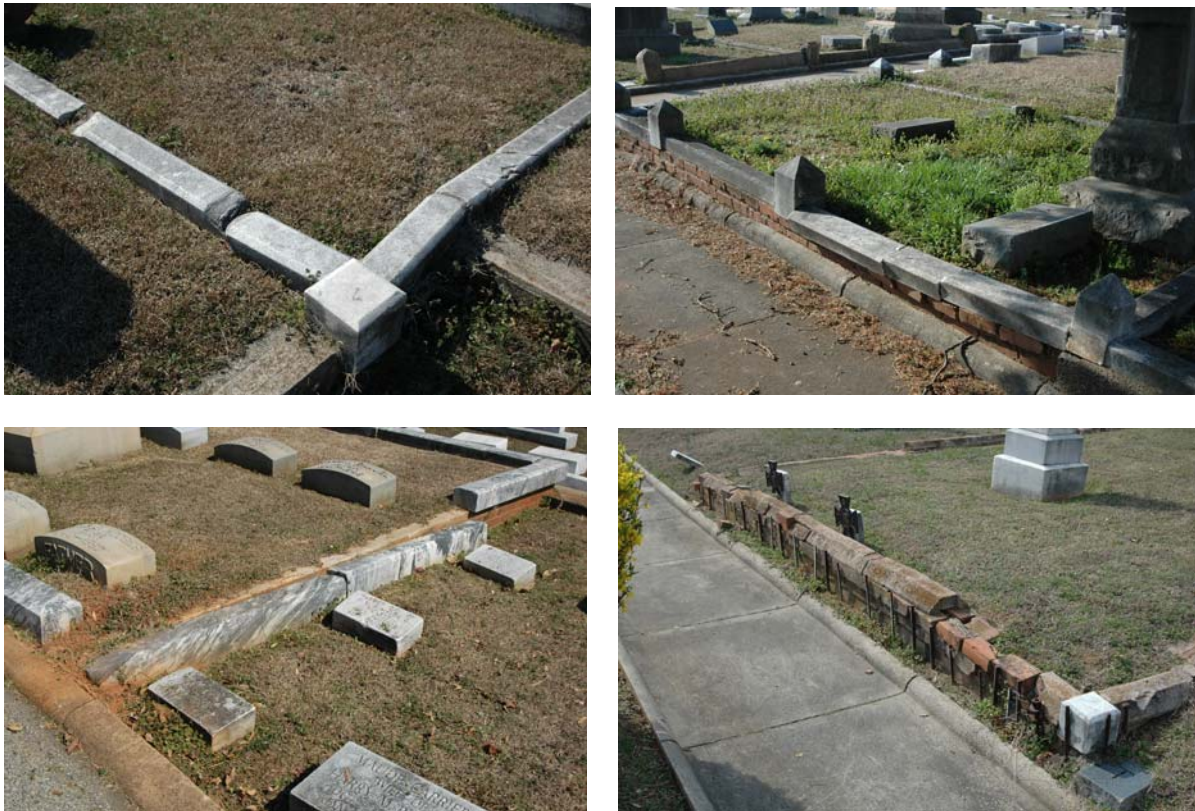
In some cases the problem is limited to displaced sections or corner posts. In other areas sections are broken and displaced. At least one section reveals extensive loss with very poor efforts to stabilize the area. These problems not only detract from the aesthetics and historical integrity of the cemetery, but in many cases also

Figure 52. Examples of plot coping damage at Springwood. Broken coping with poor repairs (upper left), broken curbing beginning to collapse off brick foundations (upper right), marble coping that has fallen into an adjacent plot (lower left), and make-shift coping being held up with deteriorating metal rods (lower right). All of these pose a liability to the Cemetery.

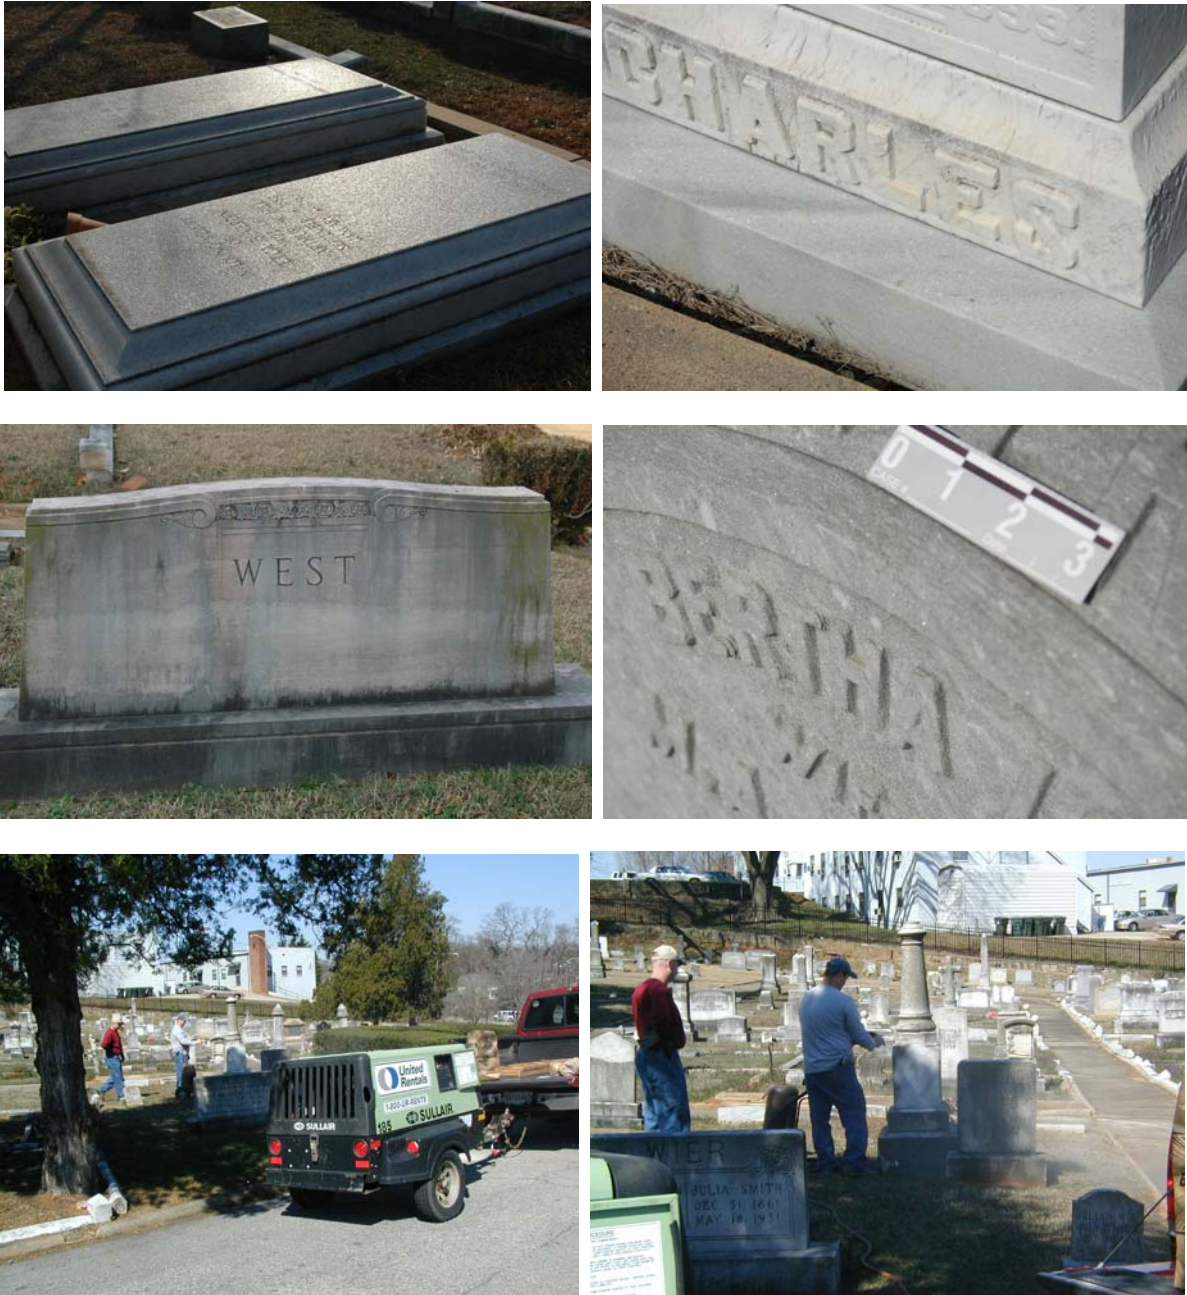
Acid cleaning, typically with muriatic acid – an impure grade of hydrochloric acid – works by dissolving the outer surface of the marble. Muriatic acid typically contains a high percentage of free iron as ferrous chloride which gets deposited on the surface of the monument, leaving yellow stains. Acid cleaning also deposits significant amounts of salts in the open pores of the stone and these salts can cause long-term deterioration of the monument.

Figure 61. Cleaning problems at Springwood Cemetery. The upper left photograph shows the unnatural gloss developed by acid cleaned marble – the result of the acid removing the outer surface of the stone. The upper right photograph shows the characteristic yellow staining that results from iron deposition. The middle left photo shows a variety of color streaks present on a stone, resulting from inappropriate cleaning. The middle right photograph shows erosion of lettering on a sandstone monument – the result of abrasive blasting. The lower photographs show a sand blasting operation in Springwood Cemetery with the operators using no personal protective equipment.

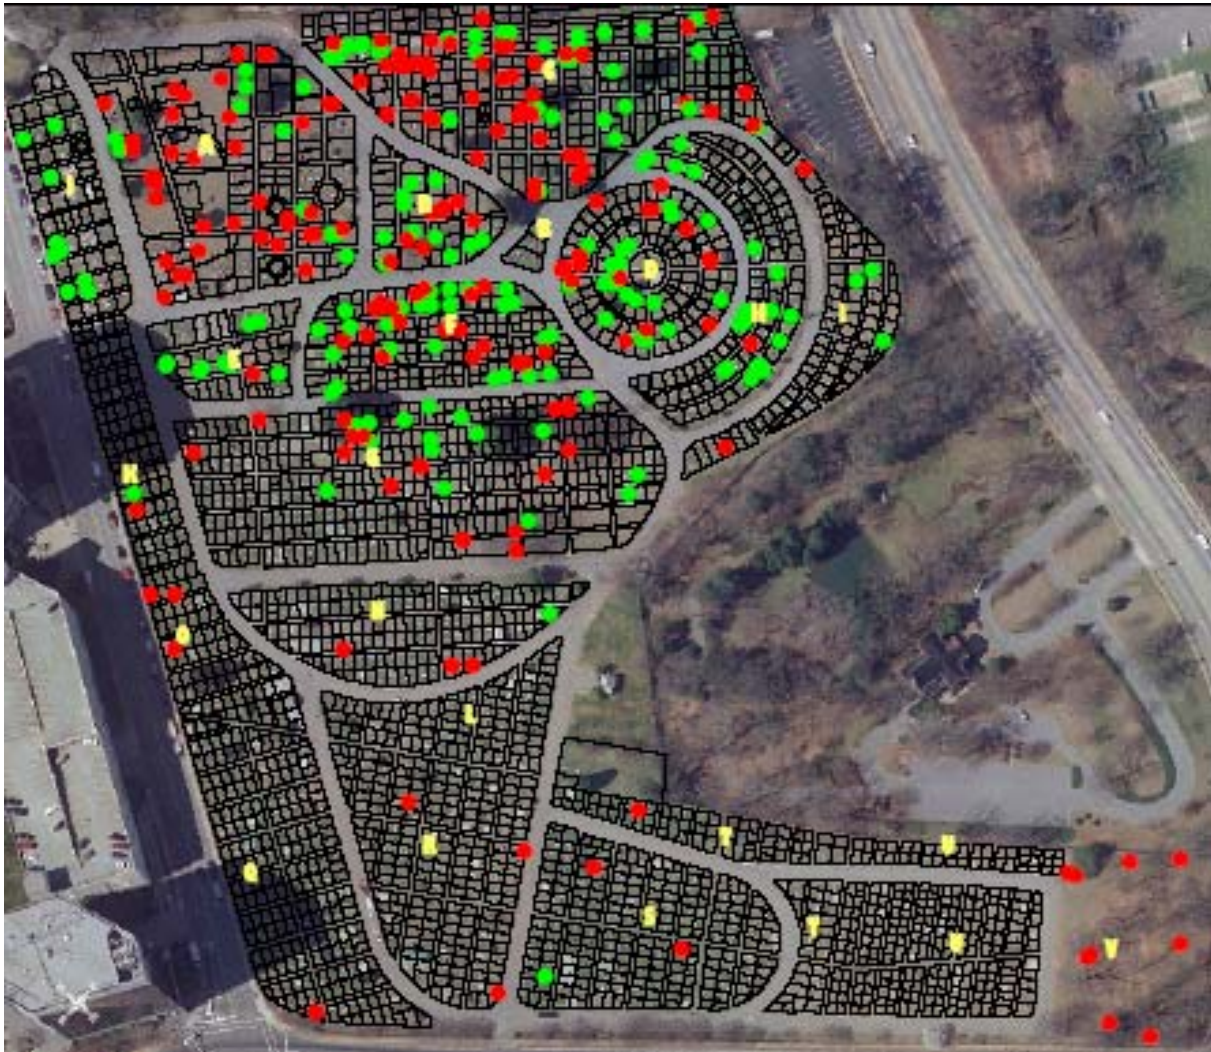
Figure 63. Monuments in Springwood Cemetery requiring conservation treatment (repair). Green dots are those initially identified by the City. Red dots are those additional monuments identified during this assessment.

In cases where stones are loose in a supporting base, resetting involves the use of a wet, high lime mortar mix. In this and all other areas of treatment, the Cemetery should avoid the use of Portland cement. It is entirely too
